51<sup>st</sup> CANADIAN  
GEOTECHNICAL  
CONFERENCE

# PERFORMANCE OF AN EXPOSED HDPE PULP MILL POND LINER AFTER TEN YEARS

ANDREW MILLS

LAYFIELD PLASTICS (1978) LTD.  
EDMONTON, ALBERTA, CANADA

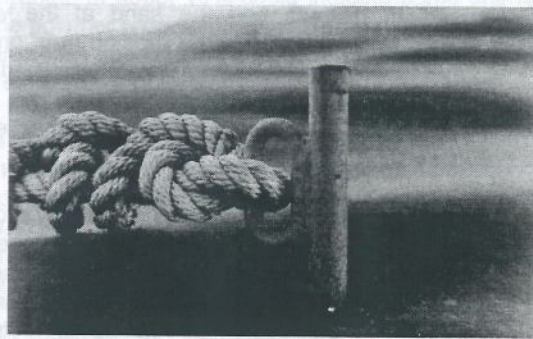
Figure 2 Stake through liner.

stakes. In a number of cases the stakes penetrate the liner (above the water level). It appeared that a round hole had been cut in the liner prior to placing the stake. A few stakes were placing stresses on the liner, however most stakes did not appear to be causing any problems.

The holes from the stakes supporting the safety net are well above the water line and should not create any problems. Monitor the liner material around these holes for any signs if cracking. If cracking occurs seek repairs immediately. Plastic deformation around the holes as a result of thermal movement of the liner should be relieved by enlarging the hole. The idea is to prevent the creation of a stress concentration point that could initiate stress cracking.

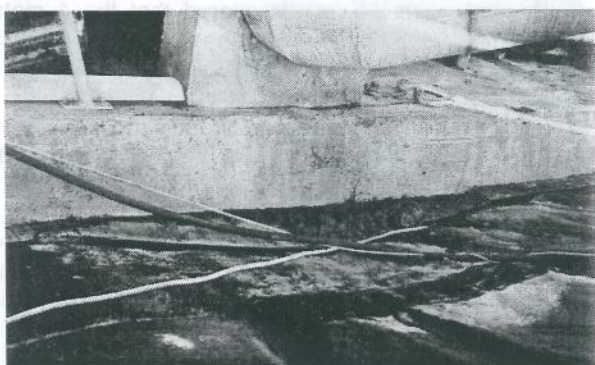
Figure 3 Erosion under the liner.

There were four areas where erosion to the subgrade on the slope was evident. An area of liner appeared "loose," with an area underneath that location (at the water line) where there was a bulge in the subgrade. It appeared that the water seeping in from the road had washed the sand subgrade off the slope and that it had been deposited at the water level as the sand could not flow freely below this point. Although underneath the "loose" area of liner there appeared to be less cushioning sand, the bulk of the subgrade sand appeared to have been deposited at the operating water line. The eroded areas did not appear to be in immediate distress and the sand at the water line seemed to be preventing the erosion from progressing further down the slope. The erosion that had occurred did not appear to be endangering the liner, however, steps should be taken to prevent further erosion in these areas.

In order to correct the problems caused by erosion from the roadway along the south pond slope Layfield Plastics recommends that the road be graded to slope water away from the pond. We also recommend that the openings in liner behind each aeration structure be filled in a way that moves water away from these openings. The restricted access where these openings are located prevents a liner repair in this area.

Correcting the drainage would present the easiest solution to the problem.

In order to prevent further erosion along the south slope the drainage pattern of the south berm needs to be changed to drain away from the pond. Regrade the roadway on the berm top and place a curb, small berm, or other impediment to water drainage to prevent water flow into the pond. Monitor the existing erosion under the liner by regular inspection (annual) and repair if the conditions worsen.

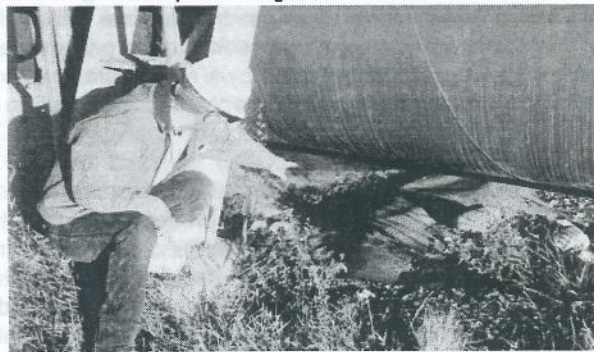
The most important problem occurred in the south slope. A modification to the electrical system in the aeration structures created an opening in the liner at the rear of each building. Water run-off from the roadway on top of the berm was flowing towards the bio-basin and eroding an area under the liner beside the aeration structures. There were a number of problems related to this erosion. On three aeration structures the erosion of the subgrade had caused settlement of the liner around the structure causing corner tears in the liner. These tears were immediately repaired prior to returning the bio-basin to service.

Figure 4 Run-off entry point that led to erosion.
