Geomembrane Performance Testing - Impacts of a Negative Langelier Saturation Index on Geomembranes

Brian Fraser, MBA., Layfield Group of Companies, bfraser@layfieldgroup.com,
Andrew Mills, C.E.T., Layfield Canada Ltd, Canada, amills@layfieldgroup.com

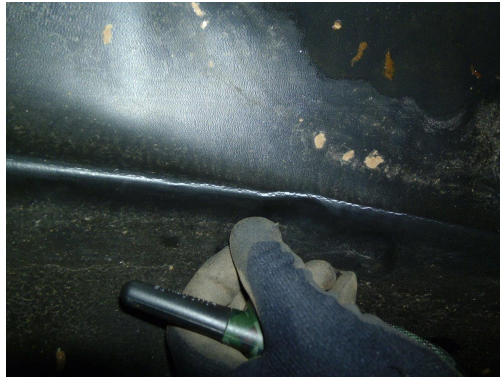
The following year there appeared to be leakage in the leak detection system and the owner hired a third party QC firm to perform an inspection. The inspector quickly found that there were problems with the repair welds and a number of the extrusion beads had come loose with resulting seam failures. Analysis of the welds showed an unusual lack of antioxidants and some cracking and crazing around the inlet pipe. The liner appeared to have been oxidized on the surface which made welding difficult. This led to a more detailed inspection where the floating cover was inflated. Inspection of the liner surface under the cover showed cracking and crazing on the bottom of the pond and in some limited areas on the slopes. The liner was cracking where it had been folded due to water pressure.

Figure 1. Damage at the top of a fold in the liner

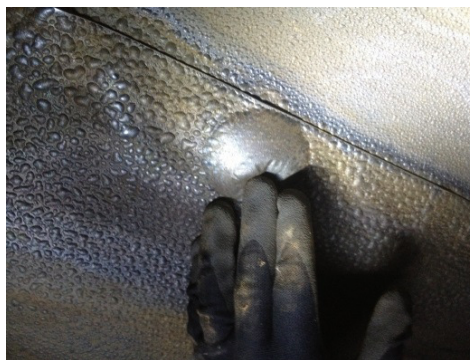
The second issue was completely unexpected. Once the inspectors looked at the cover they were surprised to see blisters covering most of the bottom of the cover. Most of the blisters were small and tightly spaced but a few larger ones were present. When cut the blisters appeared to be filled with water. The cover material had been made on 3-layer coextrusion equipment with 15%/70%/15% layer ratio. When the blisters were measured they were consistently half-way through the bottom skin layer. The bottom skin layer and the core layer were of identical formulations.

Figure 2. Blistering in the underside of the floating cover.

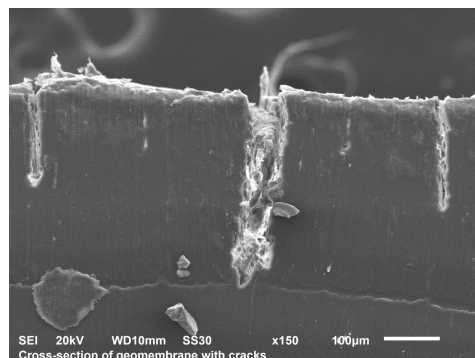
At this point we started our investigation. We tested residual antioxidants with HPOIT testing; we performed FTIR scans, and did SEM microscopic investigation of the surface and the cross section of the material. This analysis showed that the material had failed due to oxidative cracking brought on by the presence of chlorine. "Oxidative degradation embrittles the geomembrane making it more susceptible to stress cracking and lowering the material tensile strengths" (Schiers 2009).

Figure 3. SEM view of cross section showing cracking.

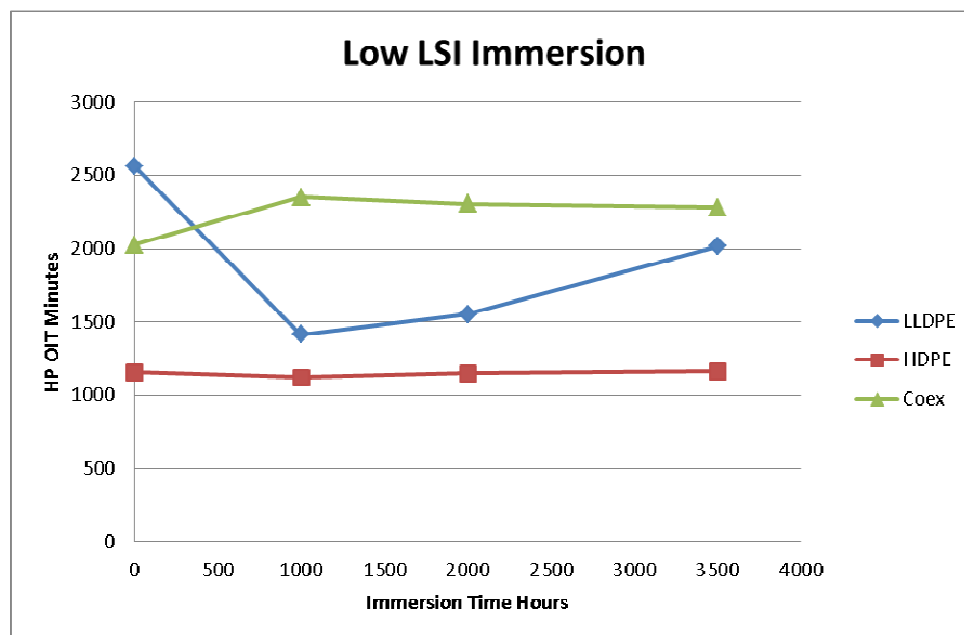
Figure 6. Results of low LSI immersion testing.

The initial results show that the LLDPE suffered an initial loss of HPOIT of a little less than half of its initial value. Continued testing after that shows an increase in HPOIT values which is unexpected. It is important to note that it proved to be quite difficult to consistently replicate the negative LSI fluid conditions from site with laboratory test conditions. Changing the fluid every week appeared to keep the conditions consistent however we are not clear on what would have caused the HPOIT values to go back up. In the control testing the LLDPE reacts as expected with no significant changes. The results for the Coex with HDPE skins and the HDPE both show good results in both immersions.

From this testing and other information obtained from our research we proposed a fortified grade of HDPE as the replacement material for the liner and floating cover. A fortified geomembrane is defined as a product heavily treated with stabilizers providing enhanced heat, UV stability and chemical resistance (Schiers 2009). In order to provide flexibility in the defined sump sections of the floating cover we proposed that strips of the Coex material be placed in the sump areas. The HDPE and the surface layers of the Coex material were both made with the same fortified formulation with an initial HPOIT value of over 3,000 minutes. With most standard HDPE geomembrane materials today being produced from Medium Density Polyethylene (MDPE) resins with a relatively low HP OIT starting level, we concluded that the fortified formulation of HDPE was a better recommendation for the owner.

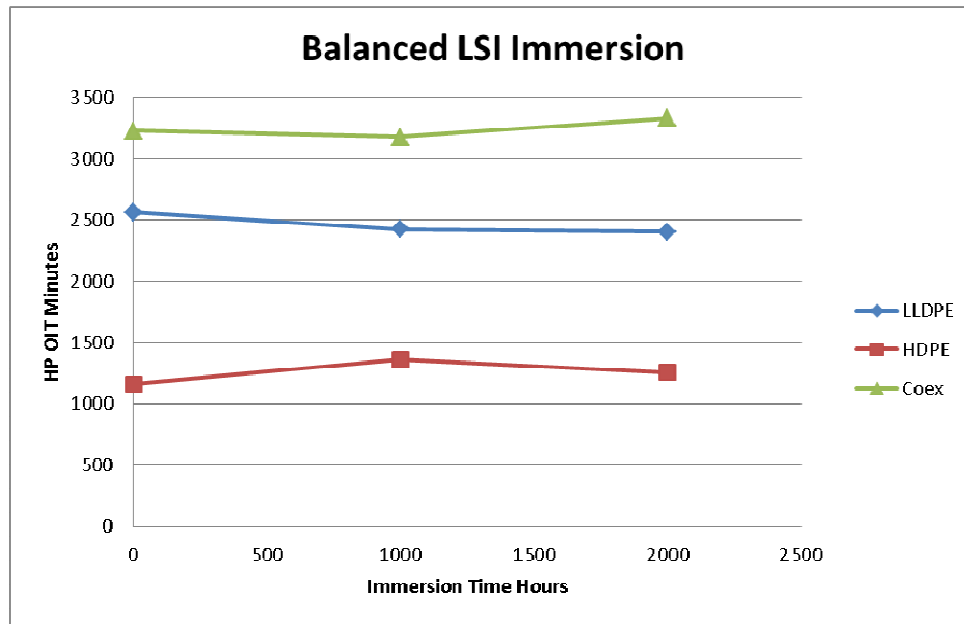
Figure 7. Control testing with balanced LSI immersion.
