A Case History on a Challenging Encapsulated Geomembrane Containment System for a Lime Sludge Pond Facility

Andrew Mills, C.E.T., Brian Fraser, MBA, Chang Park, E.I.T.
Layfield Environmental Systems Ltd., Edmonton, Alberta, Canada

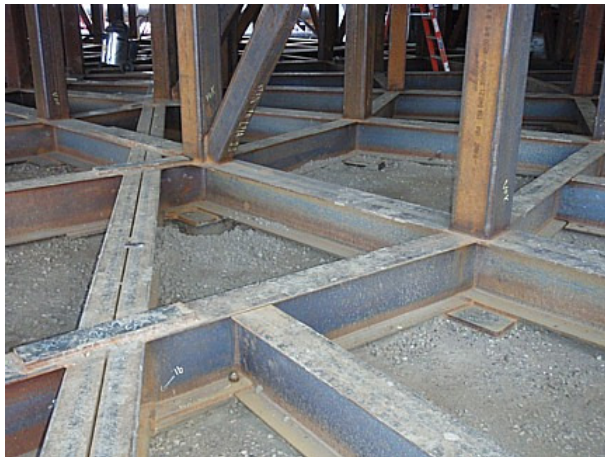
The warm lime softener tank is supported on a network of piles with a 2m air space below the tank. A spill containment liner was needed under this tank however the number and proximity of the piles precluded use of a standard liner material. A sprayed in place polyurea liner was used under this tank.

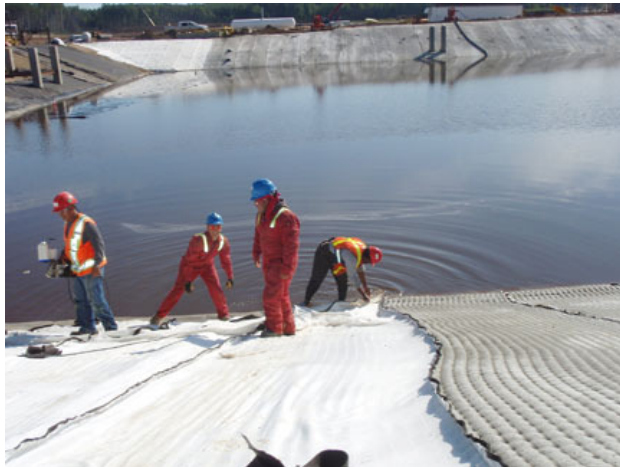
Figure 3: Installation of Fabriform concrete lining

concrete on a side slope is more difficult. On this project 100 mm thick fabric forms for concrete were used. These forms consist of two layers of fabric tied together with threads to create a uniform section. Sections of fabric forms are sewn together to cover the area required and then filled with a pumped structural grout. Once the grout hardens a solid layer of concrete is in place. On this project the fabric forms were prefabricated into large panels prior to delivery and the sewn together on site. Because of the weight of concrete over the length of the slope fabric bulkheads needed to be placed inside the forms to limit the amount poured at any one time. In this project the forms were filled 1/3 of the way up the slope and then allowed to cure before the next section was filled.

Fabric forms 100mm thick were used to place concrete on the slopes of the pond while 150mm of roller compacted concrete was placed on the base. A road way and turning pad was constructed with rig matting to provide a route for the dump trucks to get into the bottom

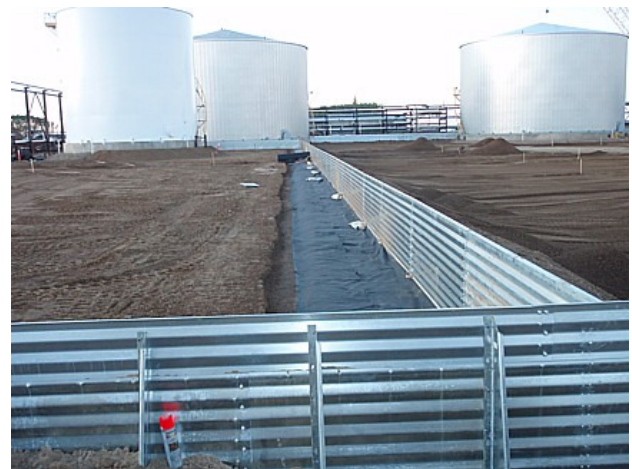
Steel containment berms are made from sections of corrugated steel supported with posts or other structural sections. In this project the steel walls were 1.4 m high. A special ground plate that works with this system is placed on the ground and extends into the dyked area. Backfill on this ground plate and any spilled liquid from the tanks prevents tipping of the wall during a spill event. The ground plates are known as a zero ground disturbance system.

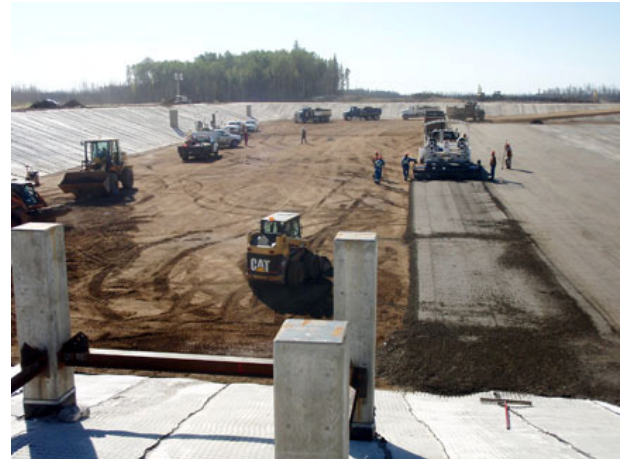
Figure 4: Installation of RCC

of the pond. Once in the pond the trucks backed up in a straight line to the concrete placement machine without making any turns on the liner.

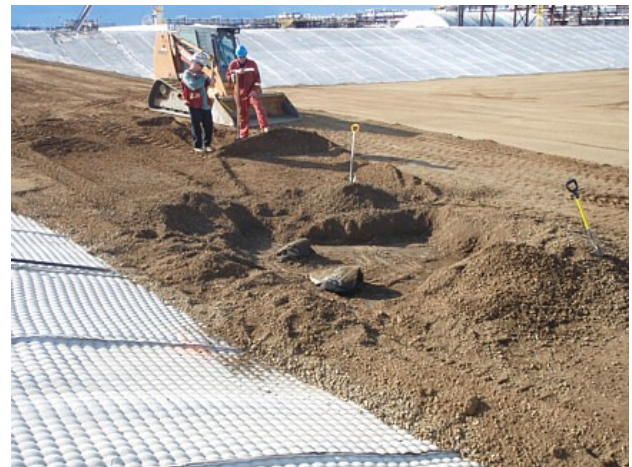
During the removal of the rig mats a forklift inadvertently put its forks through the backfill and damaged the liner system. The liner installer's site superintendent noticed the damage. The backfill was removed for 15 m on all sides of this damaged area and the liner layers were opened up to inspect each layer. Since the damage was caused by a sub trade the costs for repair were born by that contractor.

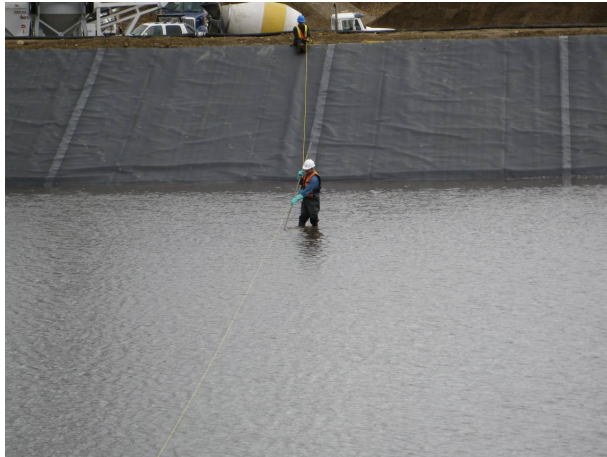
Figure 2: Leak Location Survey

The electrical leak location method impresses an electrical voltage between the contents of the pond and the earth surrounding the pond. The plastic geomembrane acts as a dielectric insulator between these two media. A leak shows up as a flow of current from the pond contents to the earth and is detected by a mobile probe. This method shows discontinuities in the geomembrane which could potentially be leaks. Not all discontinuities detected are leak paths (a carbon agglomeration in the sheet could create a non-leaking electrical path) but all discontinuities found are repaired.

One of the limitations of this test method is that connections to ground such as pipe penetrations and structures show as large leaks. Careful design of a pond is required to eliminate or limit these leak signals. Usually this includes using plastic pipe, capping steel batten bars with geomembrane, and completely covering concrete structures with geomembrane where they contact the pond contents. In this project the designers did an excellent job in isolating the concrete structures by placing the liner underneath the structure and eliminating all potential leaks. This pond was ideally suited to leak location testing.

survey at pond completion is satisfactory. When backfilling a single-lined pond leak location surveying is often done after the backfill is complete to detect any damage. In double lined ponds it is possible to test one or both geomembrane layers. Usually only one layer is tested due to cost. Adding 1 m of water to a pond can sometimes add significant cost and is usually only done once. In some cases testing the secondary liner is done followed by a water test of the primary liner. In other cases the leak detection zone is flooded and only the primary liner is tested. That was what was done on the lime sludge pond. Five small leaks were found in the leak survey and were marked and repaired.
