The Practical Limits of Cold Temperature Geomembrane Installation in Northern Canada

Mills, A., Fraser, B., Gulati, D.
Layfield Canada Ltd, Edmonton, Alberta, Canada

*Challenges from North to South
Des défis du Nord au Sud*

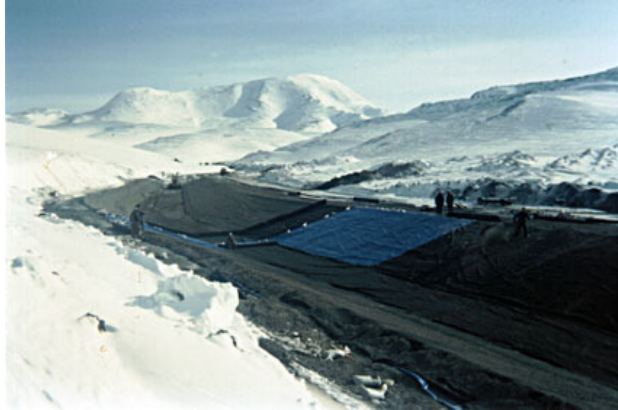
Figure 1. Winter install of RPE stream diversion in Alaska

Since the 1980s a material called Reinforced Polyethylene (RPE) has been fabricated to large sizes for winter installations. Projects using RPE included the stream diversion at an Alaska mine site in Figure 1 and many kilometers of irrigation canal installed in Alberta in the winter in Figure 2.

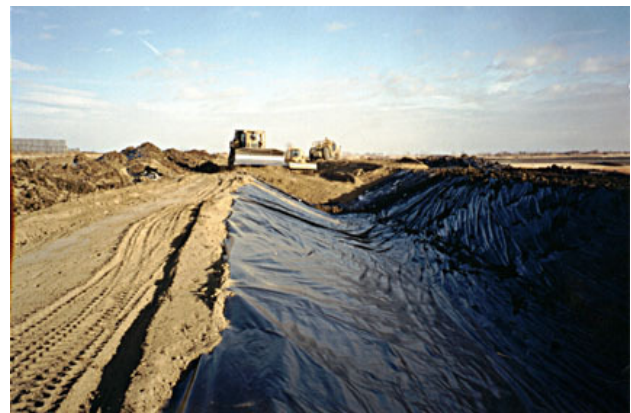
Figure 2. RPE irrigation canals in the winter in Alberta

Seaming of the RPE materials in the winter consisted of overlapping the seams 1.5m and then backfilling. Where additional waterproofing was needed a butyl tape was used in the overlap. For seepage control in fresh water applications these geomembranes were effective for winter installations.

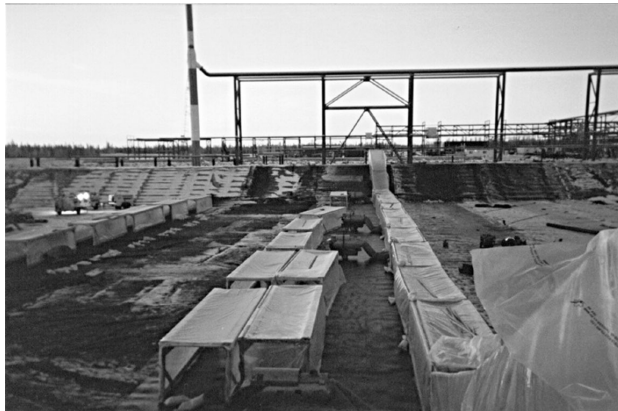
Figure 3. HDPE installation using temporary shelters.

Since 2008 winter installation has become a common practice in Canada. A couple of examples include Figure 3 which is an HDPE installation of a process pond for an oil sands project in northern Alberta. Temporary shelters were used to shelter the welding area. These shelters were helpful under certain conditions however the extra work to move the shelters did not justify their continued use.

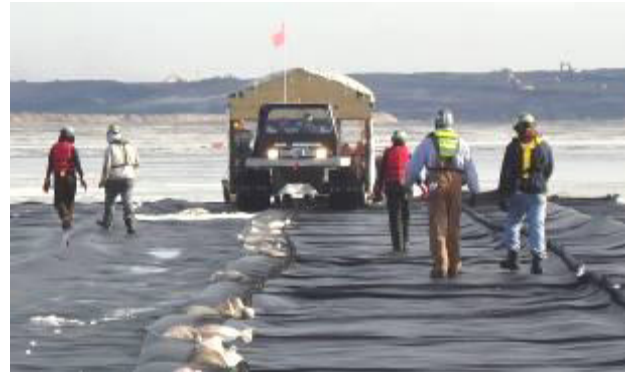
Figure 4. Placement of geotextile on frozen tailings pond.

Another significant winter installation showing the limits of winter weather is in Figure 4. This project was the installation of sewn high strength geotextile on top of a frozen tailings pond. Geotextile sewing machines are sensitive to the cold so this required heating sewing shelters in addition to cold weather deployment. This project was outlined in a paper presented at the Pan-Am CGS conference in 2011 (Mills, 2011).

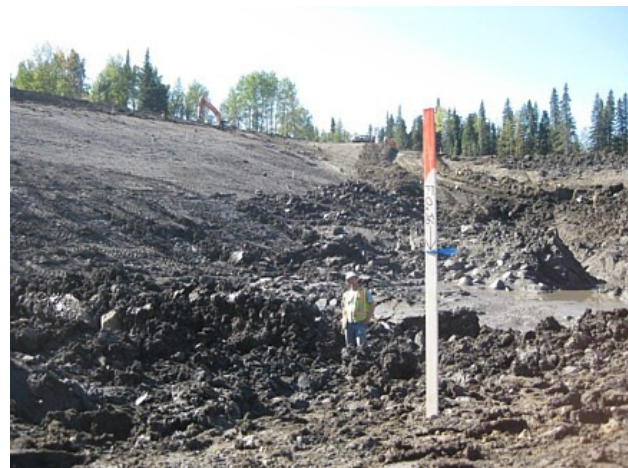
Figure 5. Subgrade preparation in wet conditions.

The project started on October 26th with crews on site to weld the HDPE pipe for the sumps. Because the crews were on site early for this preparatory work there is a good photo record of the site preparation. Figure 5 shows the condition of the subgrade in October and Figure 6 shows the final subgrade preparation. The earthwork crews did an excellent job on this project under difficult conditions.

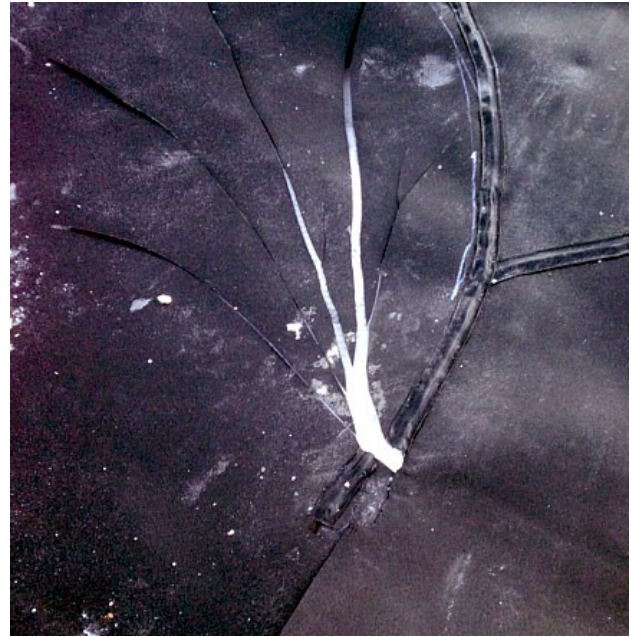
Figure 7. Cracking of the geomembrane.

Again the material was passing the material specifications but problems were occurring during installation. In Figure 7 the cracking is evident next to an extrusion seam. As outlined earlier extrusion seams can develop stresses in the geomembrane especially when cooled quickly. The conclusion was that the extrusion welds were placed at too cold a temperature. Additional temperature monitoring would be put in place to limit problems. Over the following week there were no welding issues as the field crews waited until temperatures warmed to -20C before welding.
