## Upper Chiquita Reservoir Floating Cover and Liner

Andrew Mills, Layfield Environmental Systems Corp, USA, [amills@layfieldgroup.com](mailto:amills@layfieldgroup.com)  
Sven Falk, Layfield Environmental Systems Corp, USA, [sfalk@layfieldgroup.com](mailto:sfalk@layfieldgroup.com)

### ABSTRACT

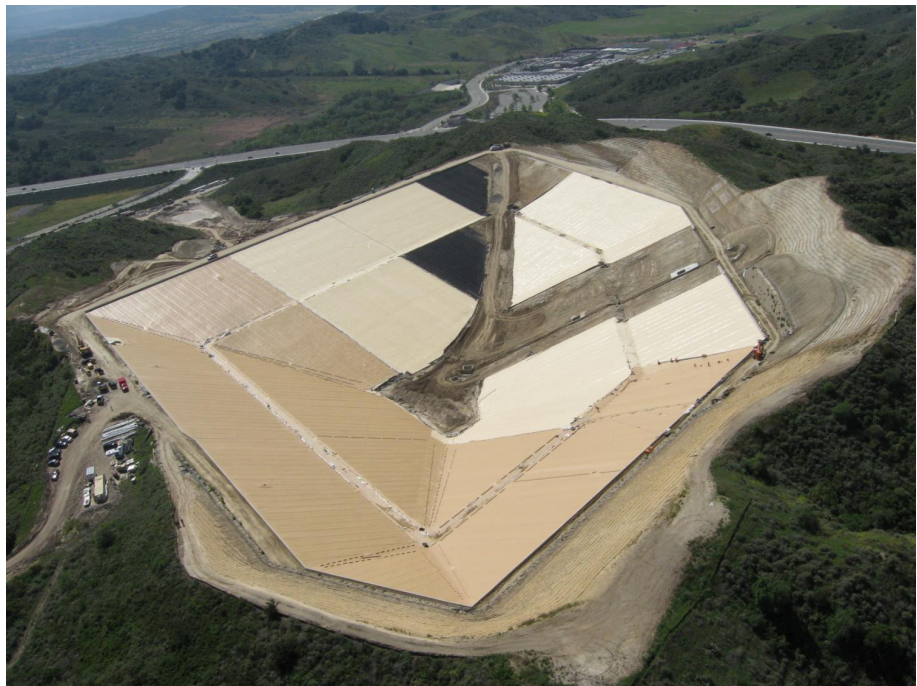
Figure 1: Aerial view of the Upper Chiquita Reservoir under construction.

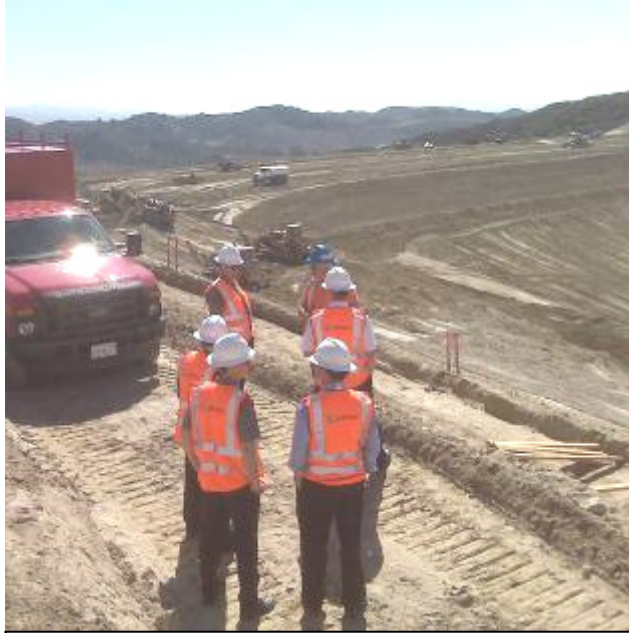
Figure 2: Site visit during the construction of the dam.

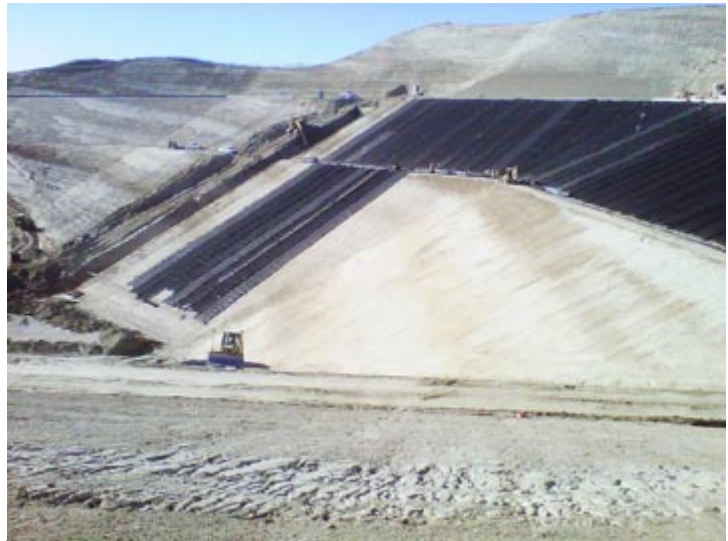
Figure 3: Placement of the geocomposite underdrain.

A geosynthetic under drain was placed as the first layer of material underneath the entire reservoir. This underdrain was placed to monitor the performance of the lining system and to provide drainage during construction. The underdrain also provided drainage for the earthen dam section. The underdrain consisted of a tri-planar double-sided geocomposite. The core of the geocomposite was 300 mil (7.6mm) thick and was sandwiched between two layers of 8 oz/yd<sup>2</sup> (270 g/m<sup>2</sup>) non-woven polypropylene geotextile.

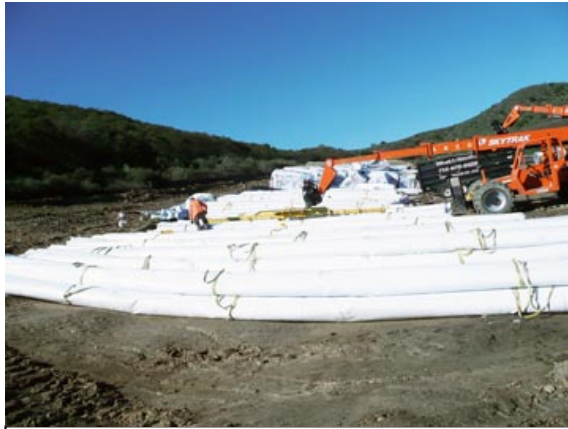
Figure 4: 36 ft wide prefabricated liner panels

The fRPP materials for the liner were prefabricated prior to installation according to a detailed panel layout. All seams were welded using a 3" wide wedge welder that bonded the materials together edge to edge without leaving a flap of material at the seams. In order to reduce creases in the lining material the fabricator on this project used a 36' wide

winder to create rolls of fabricated materials that did not require any folds in the material. There is some thought that creases in fRPP materials can lead to stress concentrations that can initiate failures. This is especially problematic in thicker materials such as a 60 mil material. By fabricating without folds this particular fabricator was eliminating this area of potential problems.

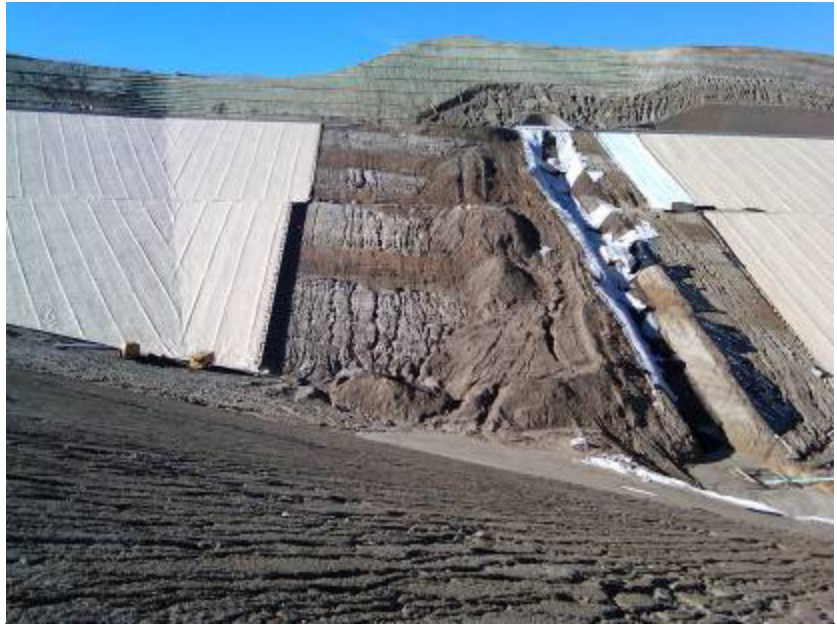
Figure 6: Subgrade damage after a significant rainfall event.

The construction of the reservoir started in the summer of 2009 and progressed well until the winter of that year. The winter of 2009/2010 was very rainy and there were many project delays. The large volumes of water kept the base of the reservoir very wet so that the earthworks could not be completed and the lining could not cover the base of the reservoir. The winter of 2010/2011 was even wetter with one particular week seeing over 10 inches of rain. "The rain gauges overflowed three days in a row" said Bart Lantz, project manager for SMWD. This rain event washed out a portion of the subgrade underneath the liner and a large section of liner had to be removed and the subgrade repaired. Over 200,000

ft<sup>2</sup> of liner was pulled back to access this repair area. It took more than a month for the earthworks contractor to dry out the site after this rain event.

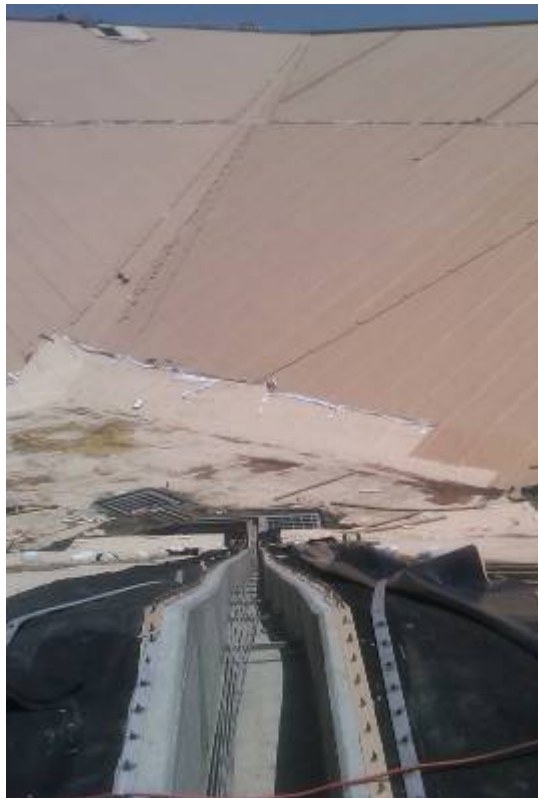
Figure 7: Pneumatic tubing in concrete trough

The first steps were to send divers into the reservoir to see if they could spot any obvious leakage. Immediately they detected leakage in the concrete trough area that carried the pneumatic lines to the base of the pond. Using underwater epoxy the divers attempted to stop the leaks however there appeared to be too many leaks to stop effectively with this technique.

The reservoir was drained and the cover and the liner were cut back to expose the concrete trough. The trough was completely filled with additional concrete and then matched to the surrounding the subgrade. The geocomposite and liner materials were then extended over this sealed trench. The operators of the facility were concerned about the maintenance implications of sealing the pneumatic lines in concrete so a secondary set of pneumatic lines were placed on top of the liner in case they are needed in the future. The facility will operate with the encapsulated pneumatic lines until they malfunction and then a diver can switch the lines over to the newer lines on top of the liner using valves in the reservoir. Once the new lines were completed the cover was repaired and the reservoir brought back into service.

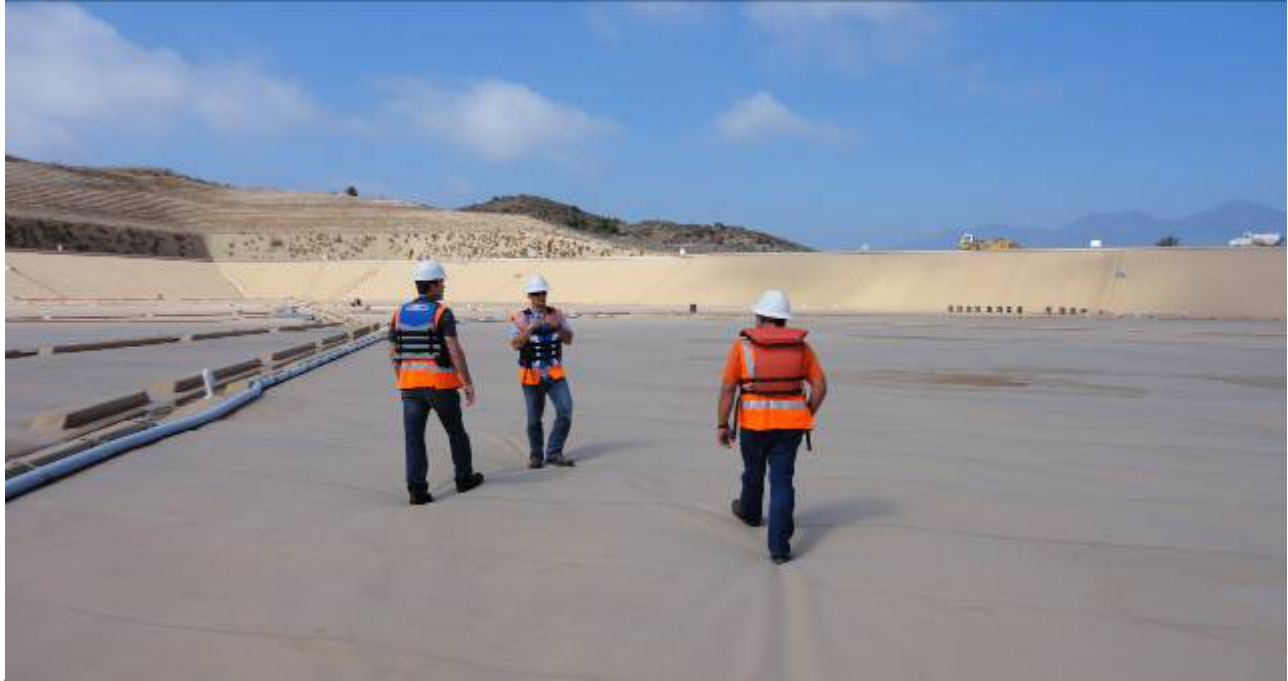
Figure 8: The Upper Chiquita Water Reservoir of the Santa Margarita Water District filled and in service.

The Upper Chiquita Reservoir is the culmination of a long range plan to ensure water security to Santa Margarita Water District and area users. The reservoir is operating as designed and is not experiencing any further issues. The reservoir is an excellent example of a large covered potable water reservoir typical of the California area.
