There are some times when an unusual project becomes absolutely unique. That's what happened recently on a water reservoir project on Catalina Island. It had been interesting enough dealing with tour busses and bison during pond construction but when the reservoir made it through a wild fire unscathed it became truly memorable.

The Wrigley reservoir is the main treated water reservoir on Santa Catalina Island, California (Catalina Island). Located on the mountain above the town of Avalon, the reservoir provides treated potable water to the town and other parts of the island.

In 2006 Layfield was invited to replace an existing liner and cover on the Wrigley reservoir. The project included 120,000 ft<sup>2</sup> of 45 mil potable water grade Hypalon for the liner and a similar amount for the floating cover. The liner and cover replacement was fairly straight-forward; what made the project unusual was its location and the events that happened later.

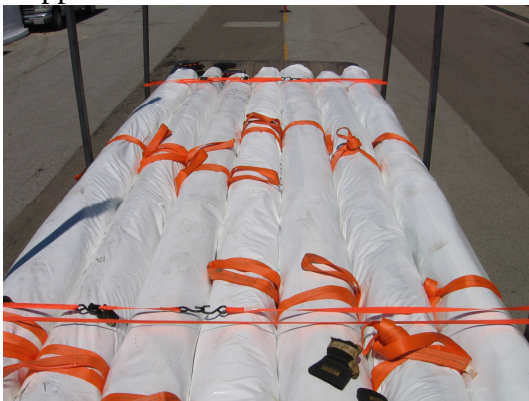
Early in 2006 we started fabrication of the liner and cover for the reservoir. As part of our ISO 9001 quality program we performed an inspection of our manufacturer's facilities in Hollister CA. Burke Industries was the manufacturer of the reinforced Hypalon used for this project and they fully met the requirements of our inspection. From there the material went to the Layfield fabrication shop which at the time was also in Hollister. Panels were welded to the custom sizes needed to fit the panel layout of the Wrigley reservoir. There were two things unique about the fabrication. The first was that we used 3 inch wide welds for all welding on these panels. The 3 inch wide weld extended to the edge of the top panel effectively welding down the edge and eliminating a flap on the surface. The other unique aspect was that we rolled these panels up without folds on rolls that were 34 ft wide. Our fabrication shop uses a 36 ft wide winder which allows us to create fabricated cover panels without folds. These rolled panels were then wrapped and shipped to site.

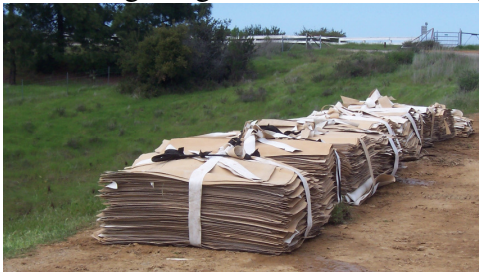
Before the installation of the new liner and cover was started the old cover material had to be removed and disposed. We met with the operators of the local landfill on the island to discuss how to dispose of the cover. They asked us to cut the cover into 4 ft x 5 ft pieces and to stack up and strap them into bundles. Garbage on Catalina Island is compacted before it is placed in the landfill as a landfill space conservation measure. By stacking and strapping the cover pieces we were mimicking the size of the compressed bricks of garbage that would normally go into the landfill.

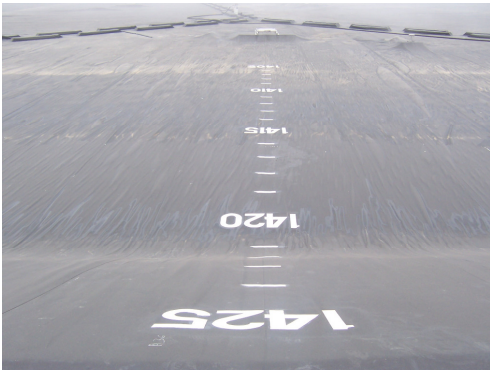
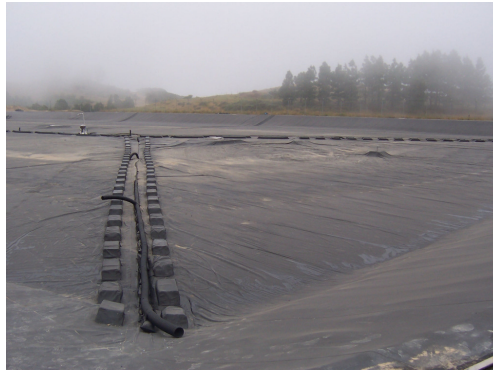
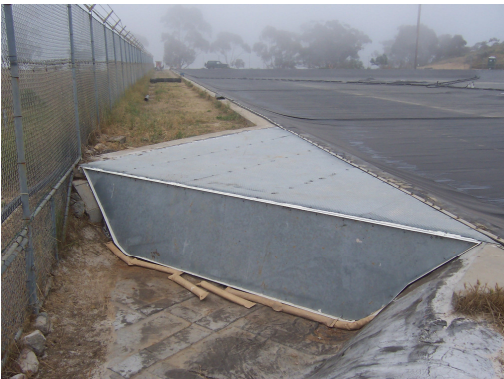
The 45 mil Hypalon cover was placed on top of the completed liner and anchored with the liner to a concrete curb at the top of the pond slope. We re-used the existing anchorage curb and steel batten bars. Once the cover was in place and tested the floats and weights required for a defined sump cover system were laid out and attached. Float covers and straps for prefabricated sand tubes were made from the same Hypalon material as the cover. We had to refurbish a large overflow structure at one end of the pond. This structure had a metal frame roof which we sandblasted and repainted. We also replaced the rainwater removal pumps and painted level markings onto the final cover.

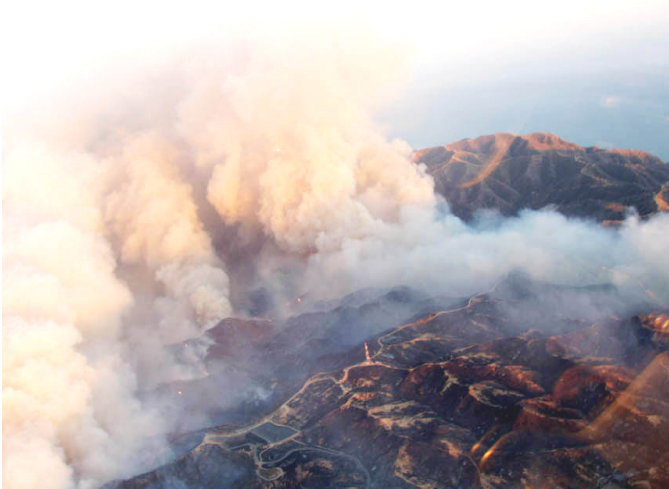
Since the Wrigley reservoir is the main source of water on the south end of the island it was an important part of the fire fighting. During the fire the reservoir was manned by two people from the water utility. They filled fire trucks directly from the reservoir during the fire. At one point the fire cut off the main road back to the town and they ended up stranded. The fire moved up the mountain and burned around and past the reservoir. The area around the facility is mostly cleared with some grasslands and one stand of trees along one side. The two utility workers took refuge in their vehicle on the downwind side of the reservoir and were unharmed. At the fire's closest approach it would have been about 100 ft from the reservoir.

In the end the fire had burned around three sides of the reservoir without apparent damage to the facility or the floating cover. There was a collection of ash on the cover but no apparent damage. In the weeks after the fire the reservoir remained in use without any measurable decrease in water quality. The floating cover had prevented ash and debris from the fire from getting into the pond so that the reservoir could remain in service.

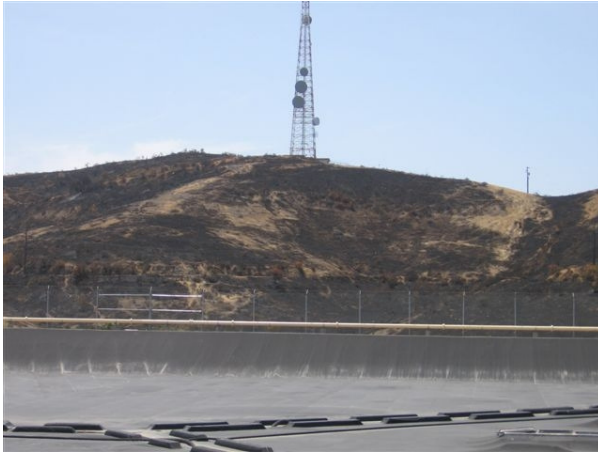
Inspection after the fire showed that a few small embers had fallen on the cover but were extinguished as soon as they burned a pinhole in the cover. The utility had the reservoir inspect by divers and did a complete inspection of the upper surface but found only a very few defects. There was a layer of ash on the cover but otherwise no significant damage.

Layfield was contacted to come and clean and repair the cover in the summer of 2007. Operational issues required that the water not be drained completely so the repairs were done while the cover was floating. Our crew repaired one hole about the size of a dime and then set about to clean the cover. The entire area was swept and then pressure washed. Water containing the ash and collected debris was pumped from the cover into a small holding pond. There was no other damage to the liner and cover system. The system remained in service throughout the cleaning.
