# **52nd Canadian Geotechnical Conference**

# GEOMEMBRANE USE IN A LANDFILL CAP REHABILITATION

RICHARD HOFFART,  
LAYFIELD PLASTICS (1978) LTD.  
EDMONTON, ALBERTA, CANADA

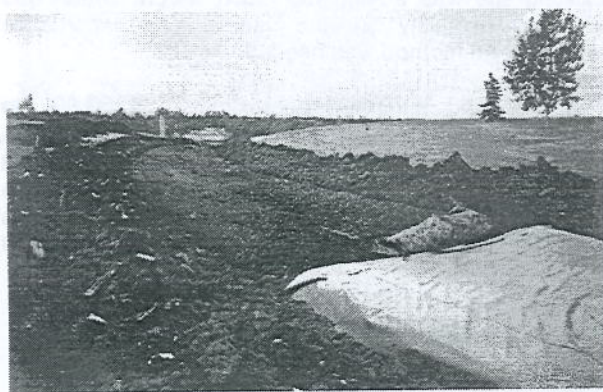
**Figure 4** Channel looking toward the river. Excavated waste is visible along the left side of the channel.

Excavation of the swale started in July of 1997. Soon after construction began it was discovered that the site had much less clay cover than anticipated. During excavation of the swale, waste from the landfill began to show up along the entire length of the swale. This development reinforced the requirement for the geomembrane as a waterproofing membrane.

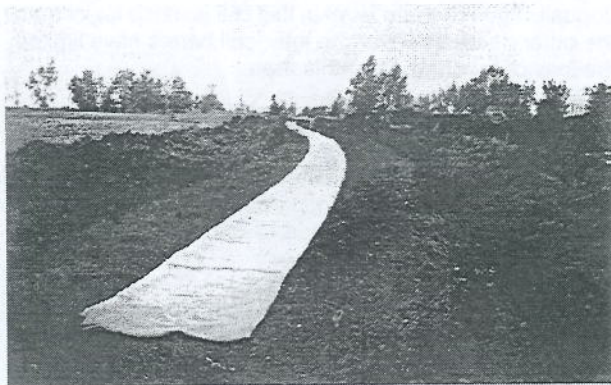
**Figure 5** Deployment of the PVC geomembrane in the channel. View is looking north along swale.

The 30 mil PVC geomembrane was installed one panel at a time. The panels were unrolled and pulled into place. As the first two panels were placed, the Layfield Technician instructed the City staff on how to solvent weld a PVC geomembrane in the field. A seaming solvent called Tetrahydrofuran (THF) was used to make a permanent chemical weld between panels. The City crew quickly learned the chemical seaming process and were soon able to successfully seam panels without the assistance of the Layfield Technician.

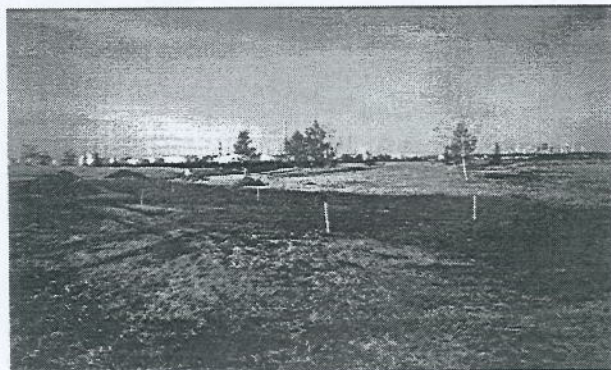
**Figure 3** The natural swale with grade stakes just prior to construction. This view is looking toward the river.

In the spring of 1997 the City visited the site to try and come up with an alternative to continuing with the earthworks proposal. As they toured the site, it was noticed that a shallow drainage swale (or channel) had naturally developed on top of the south landfill. This swale was approximately 5 meters wide and ran 250 metres from north to south, curling to the west and eventually draining into the river.

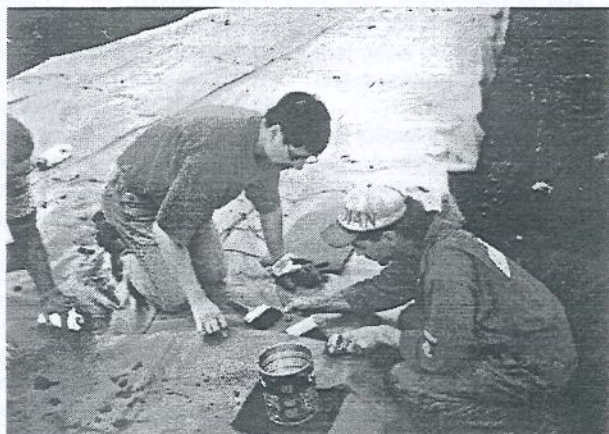
**Figure 6** Welding panels of PVC together with solvent.
